MAGNETIC
PRODUCTS AND SERVICES, INC.

**UNDERSTANDING SHAFT
VOLTAGE AND GROUNDING
CURRENTS OF TURBINE
GENERATORS**

Paul I. Nippes, PE
Elizabeth S. Galano
2135 Highway 35
Holmdel, NJ, 07733
732-264-6651

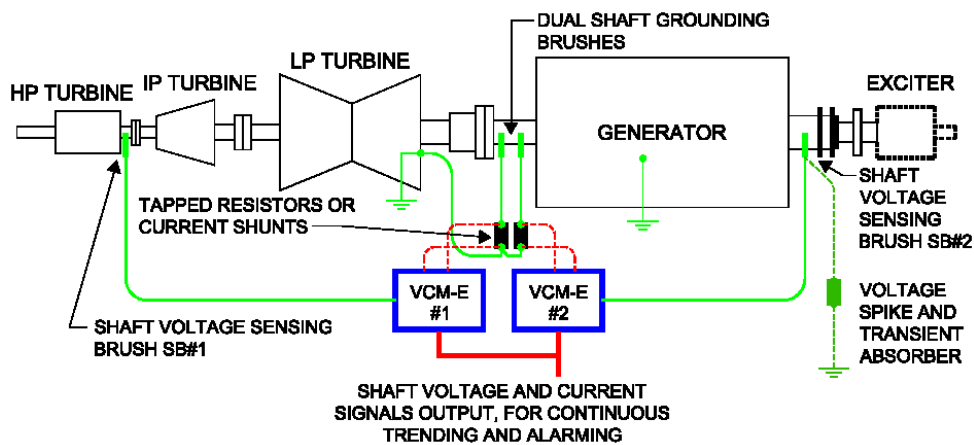
Figure 3 shows the recommended installation of complete shaft grounding and monitoring for large and critical turbine generators. Two grounding brushes are employed with current being measured by current shunts and/or tapped resistors in the cables from the brush to the nearby turbine casing and thence to the station ground grid. Two grounding brushes provide redundancy so one brush will always be grounding the shaft while maintenance or element replacement is being made on the other brush element. The increased current carrying capacity of both brushes will protect the bearings in the event of a serious electrical fault in the generator or shaft rubs within the train.

Figure 3 - Shaft Grounding, Monitoring, Protection and Warning

In addition, there are two voltage-sensing brushes, one at the turbine which will indicate voltage drop in the event of a turbine rub and will increase, should electrostatic charging take place due to wet steam in the seals or exhaust end, or possibly due to dry steam in the HP turbine. A voltage sensing brush is also placed at the generator outboard end. Its voltage will drop in the event of shaft rub or loss of bearing or hydrogen seal insulation and this will be accompanied by an increase in the shaft grounding current. High voltage at this brush with no noticeable increase in shaft grounding current usually means there are voltage spikes imposed by the excitation system, however this can be also caused by sparking collector ring brushes or a filter or diode problem in the exciter. If these are not corrected at their source, a voltage spike and transient absorber or suppressor can be placed across this brush.

Figures 12 and 13 show shaft currents and voltages for 660MW turbine generators Units #1 and #2 respectively with full monitoring systems, as shown in Figure 3. These traces were made in the engineering offices of a large utility, signals being communicated in real time from the generating station. The traces show a consistency of shaft voltages and grounding currents over periods of six days and one day respectively, having no aberrations, nor indications of unit problems. Differences in currents by factors of 2 to 3 in the shaft grounding brushes is normal since they are in parallel and divide grounding current in inverse proportion to slight differences in their parallel impedances. The generator OB voltages of 23.4 and 14.0 are reasonable values with differences possibly due to exciter filter or SCR differences. If either of these values drop to a few volts or less and the shaft grounding current picks up materially, one may expect that the generator outboard bearing or seal insulation has been shorted out and bearing damage may occur.

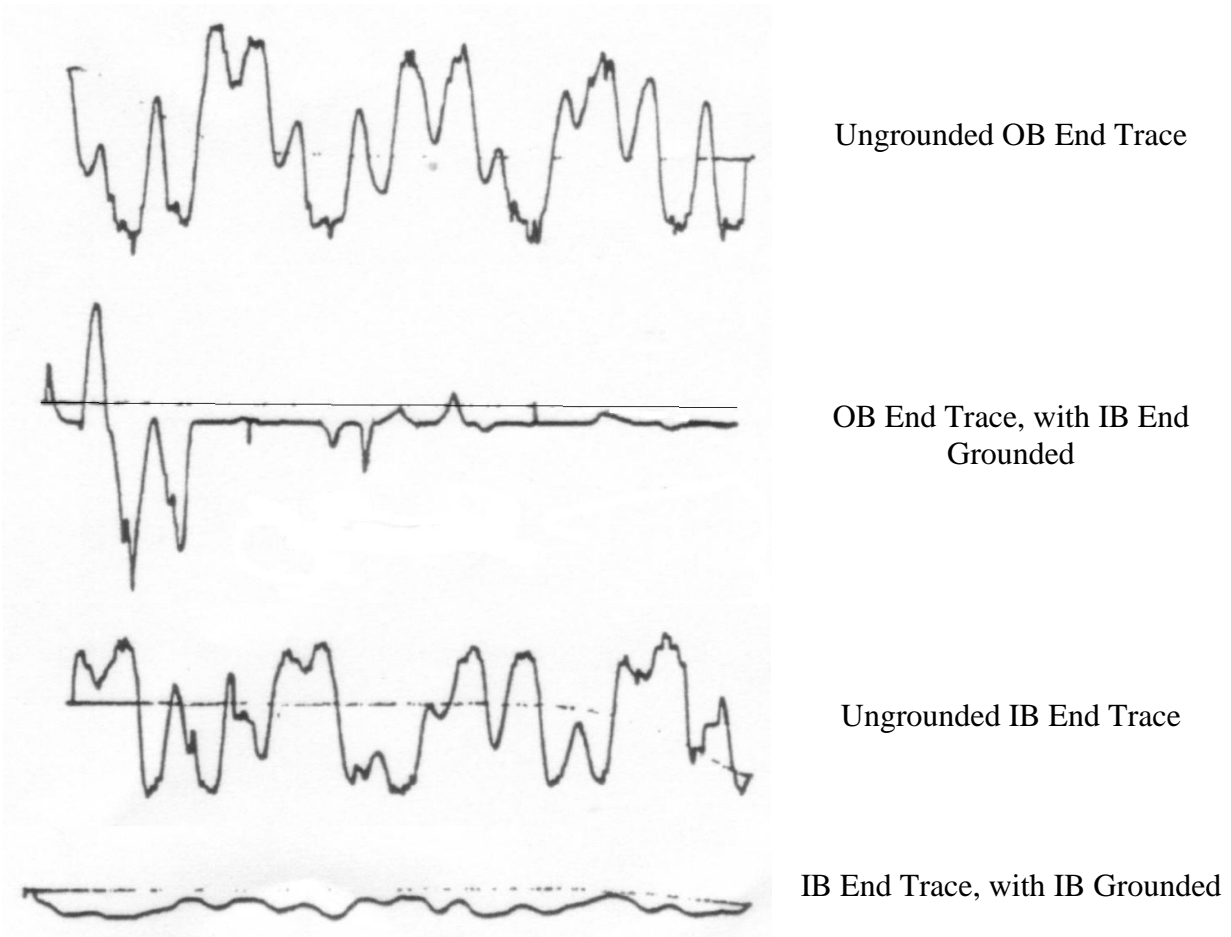
Another confusing issue encountered when making shaft voltage traces, is erratic performance of the shaft grounding brush. This is demonstrated in Figure 6, with waveforms taken on a blower motor. The motor outboard bearing (OB) was insulated. Ungrounded shaft voltages were similar on the outboard and the inboard (IB) shaft ends, showing a fundamental with a predominant 7th harmonic, indicating a source of: winding pitch, slotting plus possible capacitive coupling to the stator winding.

Figure 6 – Erratic Voltages on Shaft Grounding of a Blower Motor

Grounding the motor IB shaft end generally reduced the IB shaft end voltage significantly and continuously. An occasional voltage burst may indicate that grounding was momentarily lost, or possibly a component of the voltage was directed end-to-end and the OB end voltage existed as a normal condition. And when it disappeared, there was current discharging through the OB bearing, possibly doing damage, with the IB grounding brush as the return path.

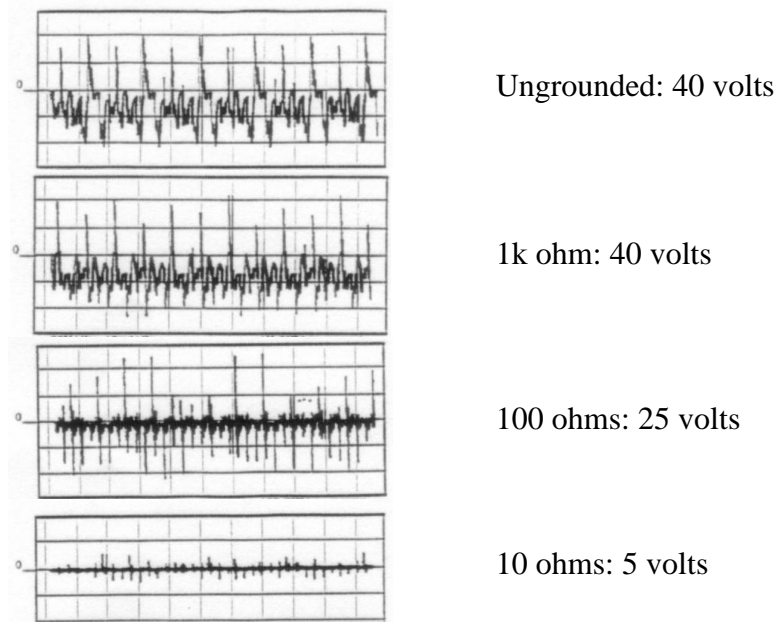
Figure 8 shows four shaft voltage traces each having different resistances in the grounding cable. Here again, the source is magnetic in nature, however, it is not clear if the source is from an electrical machine or it is from residual magnetism in either the shaft or the casing or frame of the machine. The indicator that the source is magnetic in nature is revealed by how well the grounding resistor reduces the ungrounded voltage of 40 volts. A 1k ohm resistance in the grounding cable had very little effect on the signal and the maximum voltage was still 40 volts. When the grounding resistance was reduced to 10 ohms, the shaft voltage was still 5 volts.

Figure 8 – Shaft Electromagnetic voltages with Different Resistances in the Shaft Grounding Circuit

Figure 9 shows three shaft voltage traces that are clearly from an electrostatic source. There is a repeated charge with sudden discharge commonly referred to as a “saw tooth” characteristic. And, in addition there is a significant reduction in voltage as resistors are inserted into the brush grounding cable. A 10k ohm resistance reduced the voltage from 30 volts to 4 volts while a 1k ohm resistor reduced the shaft voltage to less than 0.5 volts. This reduction is a considerable difference from the minimal effect for the inductive source shown in Figure 8.

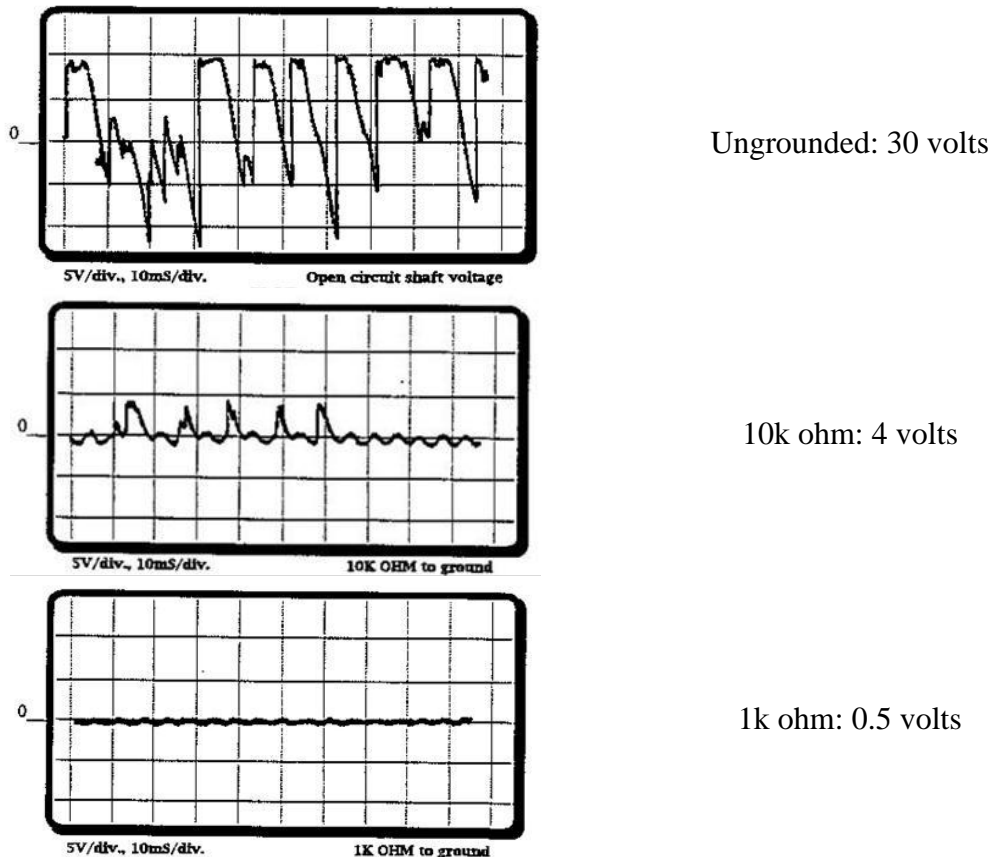
Figure 9 – Shaft Electrostatic Voltages with Different Resistances in the Shaft Grounding Circuit

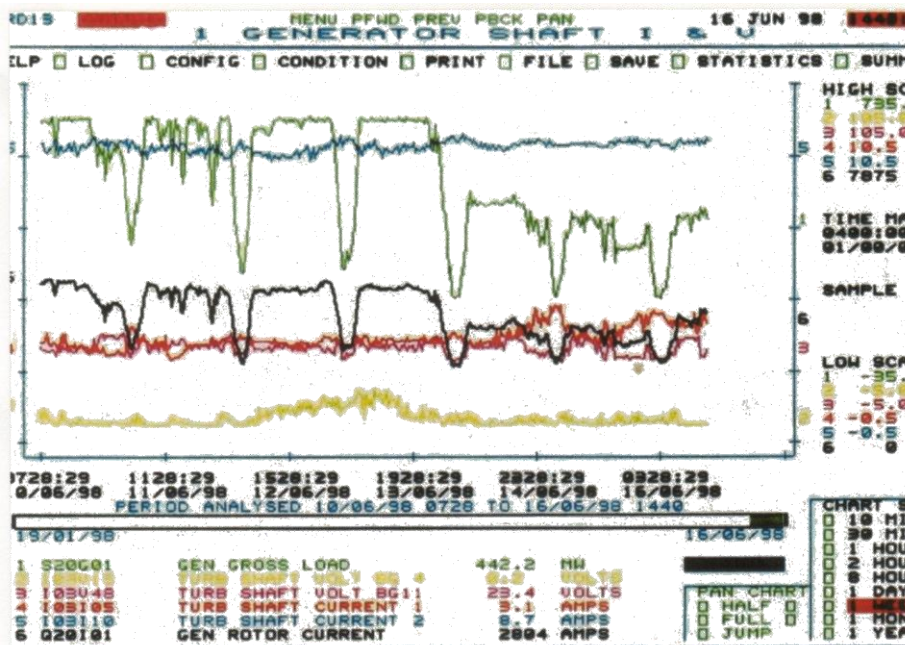
Figure 12

Unit 1 Shaft Peak Currents and Voltages for Six Days

Grounding brush Currents = 3.1 and 8.7 Amperes

Generator OB End Shaft Voltage = 23.4 Volts

Turbine Shaft Voltage = 0.2 Volts

If there is a significant rise in the generator shaft end voltage, one may expect that high excitation voltage spikes are occurring and bearing damage could occur as current spikes pass through the capacitance of the bearing insulation. Investigation of the exciter performance is in order. The turbine voltage of 0.2 volts is very safe while the 4.8 volts on unit #2 could indicate electrostatic voltage generation with possible gradual current pitting of the turbine bearings.

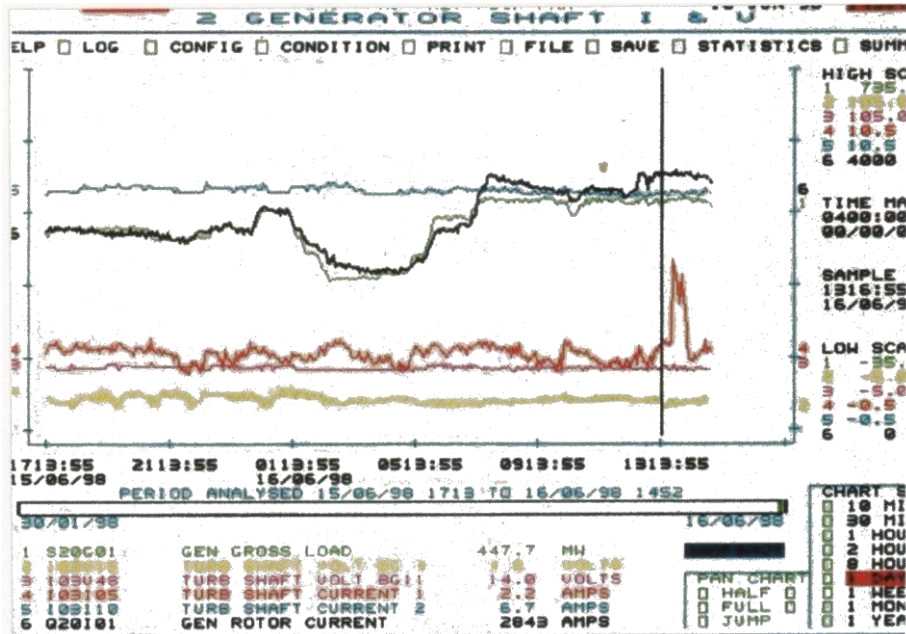
Figure 13
Unit 2 Shaft Peak
Currents and Voltages
for One Day
 Grounding brush
 Currents = 2.2 and 6.7
 Amperes
 Generator OB End
 Shaft Voltage = 14.0
 Volts
 Turbine Shaft Voltage
 = 4.8 Volts

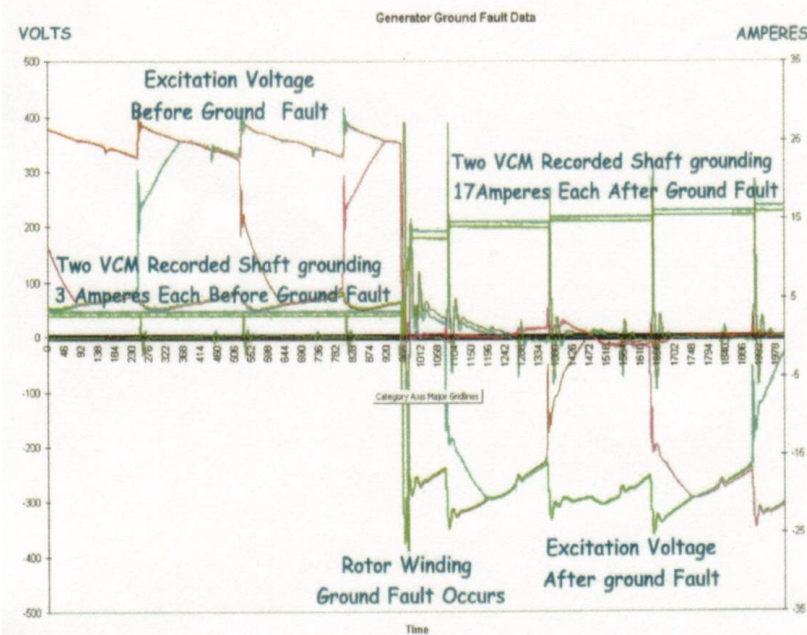
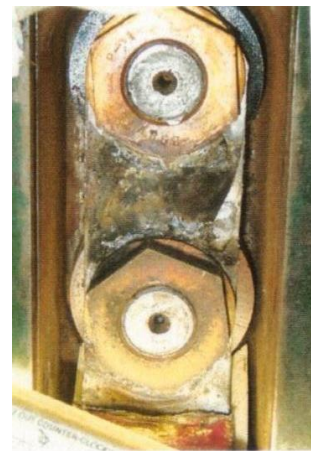
Figure 14 (left and right) demonstrates fault detection on a 500 MW turbine generator. This unit was instrumented with an event recorder on excitation voltage and a VCM registering shaft grounding current.

Figure 14 - 500 MW Turbine Generator Field Voltage Shift and Shaft Grounding Current Increase (Left) During a Rotor Excitation Winding Ground Fault (Right)

The reason for installing this instrumentation was that excitation ground fault indications were occurring and would disappear when the generator excitation current was reduced slightly, only to repeat the sequence after a lapse in time. The first ground fault indication with instruments in place produced the traces of Figure 14. Coincidentally, there was a significant increase in shaft grounding current from 3 amperes to 17 amperes on each of the dual shaft grounding brushes, a clear indication of the fault. Upon extensive examination the cause was traced to an intermittent ground fault in the bus bar carrying excitation current to the rotor winding. The current monitor detected and indicated very clearly the presence of an asymmetry in the generator magnetism created by the field ground fault.
